PRELIMINARY ASSESSMENT REPORT

Doyle, Frank J.

EPA ID NO. TXD980865109

LEONARD, FANNIN COUNTY, TEXAS

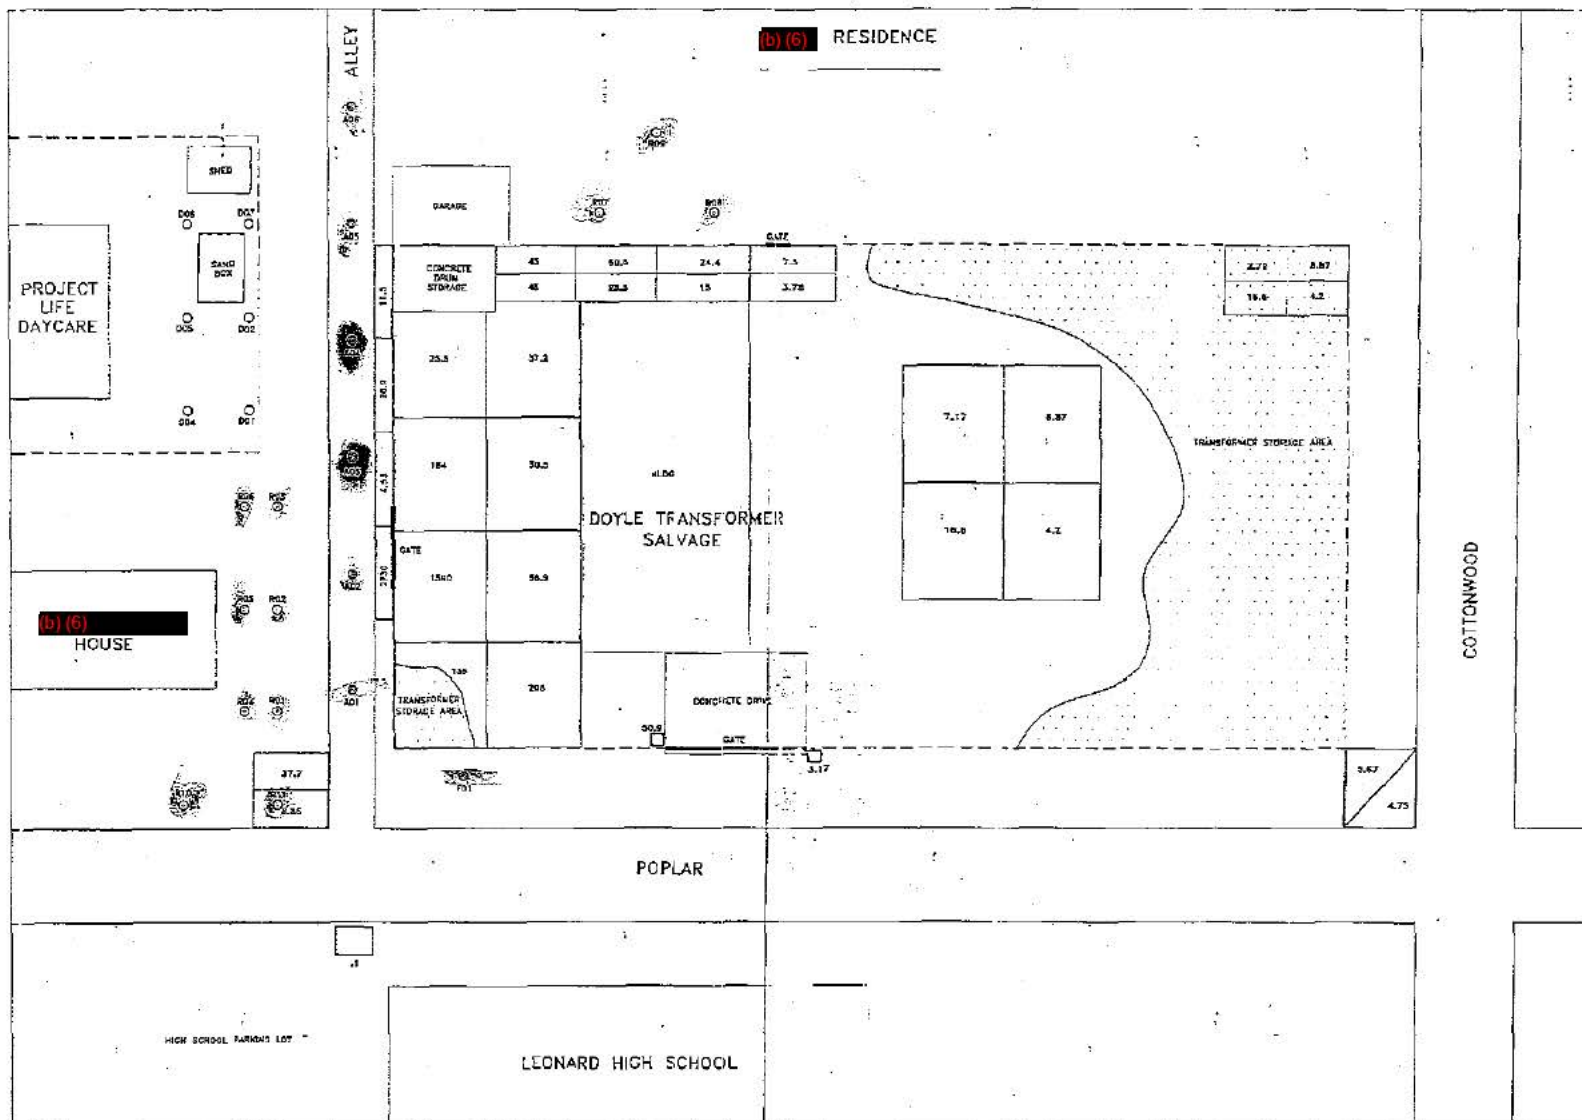
Figure 3
Sample Location Map

Soil samples were also collected in the alleyway between the site and the residence. Sample AO1 had the highest Aroclor 1260 concentration of 5.7 ppm in the 0-6 inch interval and 48.2 ppm for the 12-18 inch interval. Sample AO2 had the highest Aroclor 1260 concentration of 852 ppm at the 6-12 inch interval and a concentration of 115 ppm for 18-24 inch interval. Both of these sample locations are located across the outside storage area for the transformers and down gradient from the site (Figure 3- Sample Results Map).

collected just outside the east gate with a concentration of Aroclor 1260 of 2730 ppm. This location is outside the fenced perimeter of the site and is assessable to the public. A grab soil sample was also collected at the location of the culvert and the analytical results showed the third highest concentration of PCB Aroclor 1260 with a 50.9 ppm concentration (Figure 3).

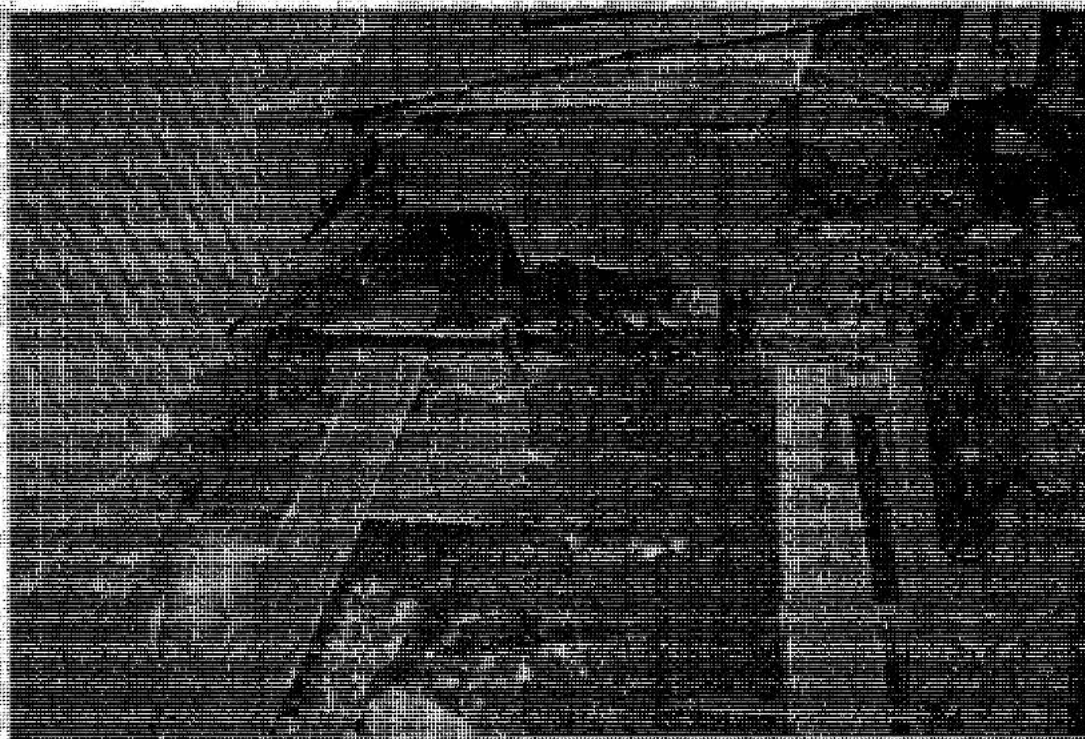
Photo No.	2
Neg. No.	2

2x4 studs located inside the fence. Notice the degradation of the of the metal building.

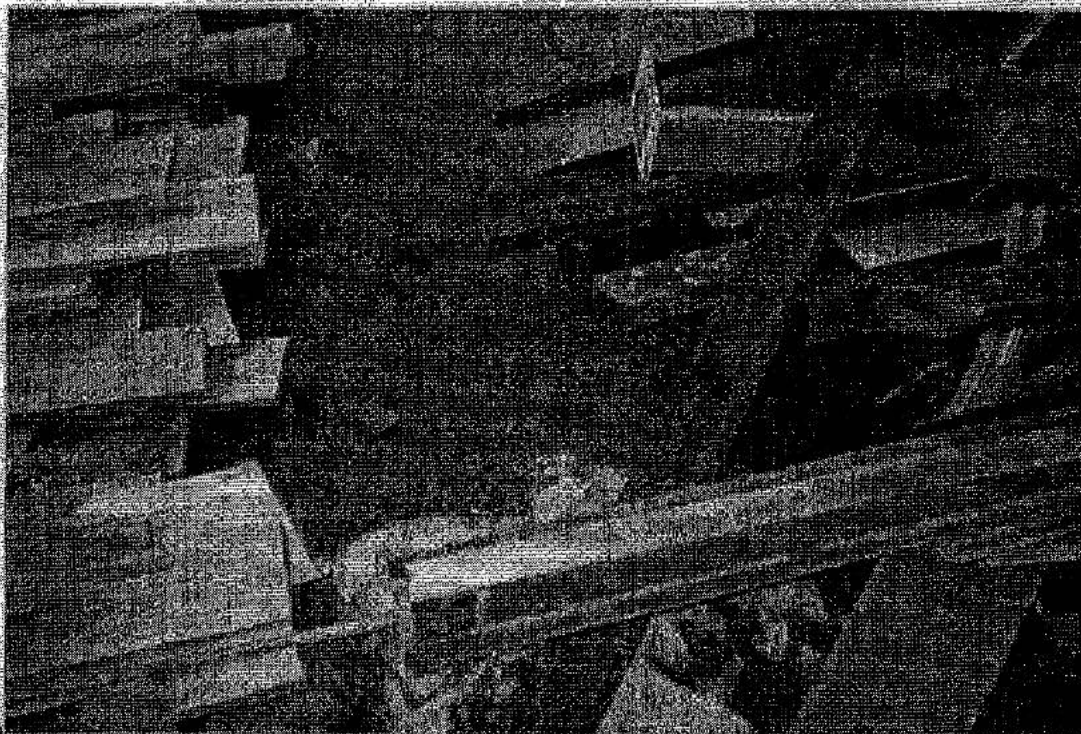
Photo No. 8
Neg. No. 6

Location: (b) (6) Date: 5/20/97 Time: 10:30 Direction:
 Description: Yellowish/green staining on the ground located outside the shop.

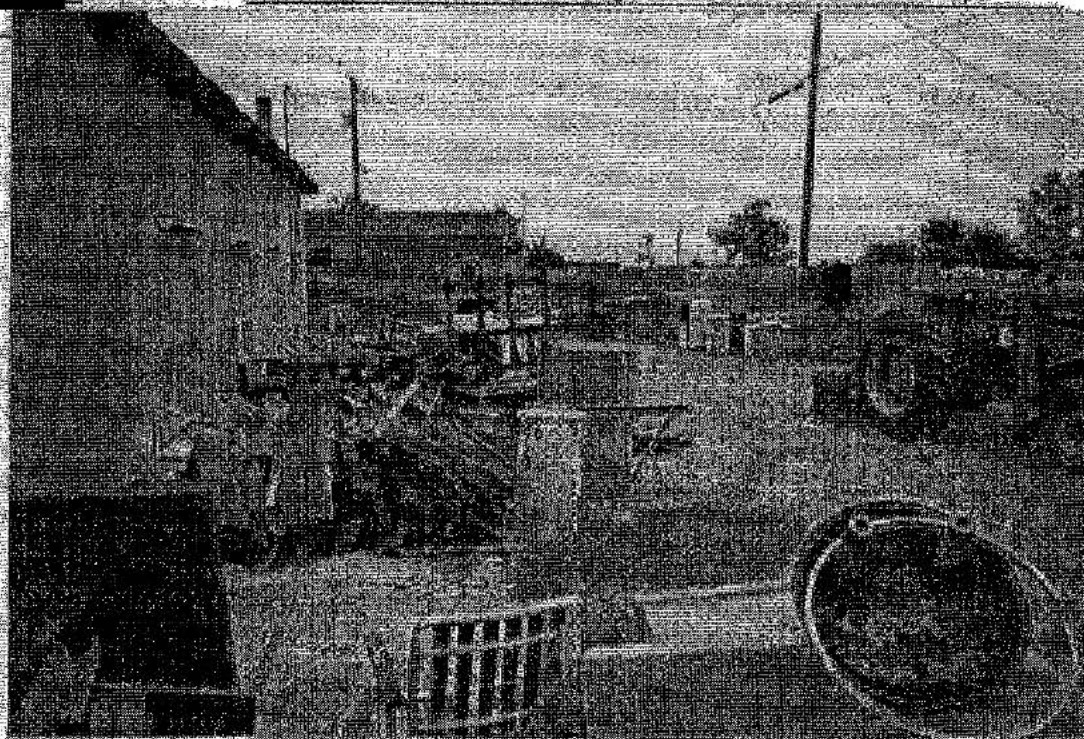
Photo No. 9
Neg. No. 7

Photographer/Witness W. Bigley/K. Westberry
 Date: 5/20/97 Time: 10:30 Direction: East
 Description: The south side of the shop. Soil staining was located near the debris pile.

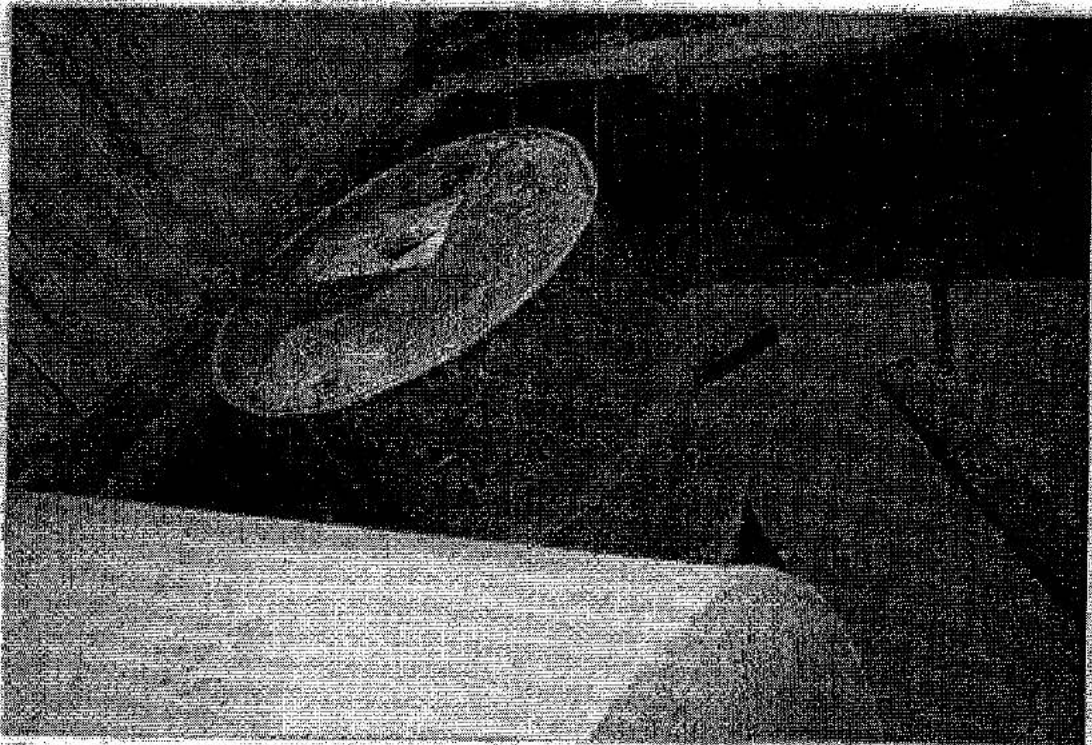
Photo No. 10
Neg. No. 8

View of the drum marked as corrosive inside the tank pit holding area.

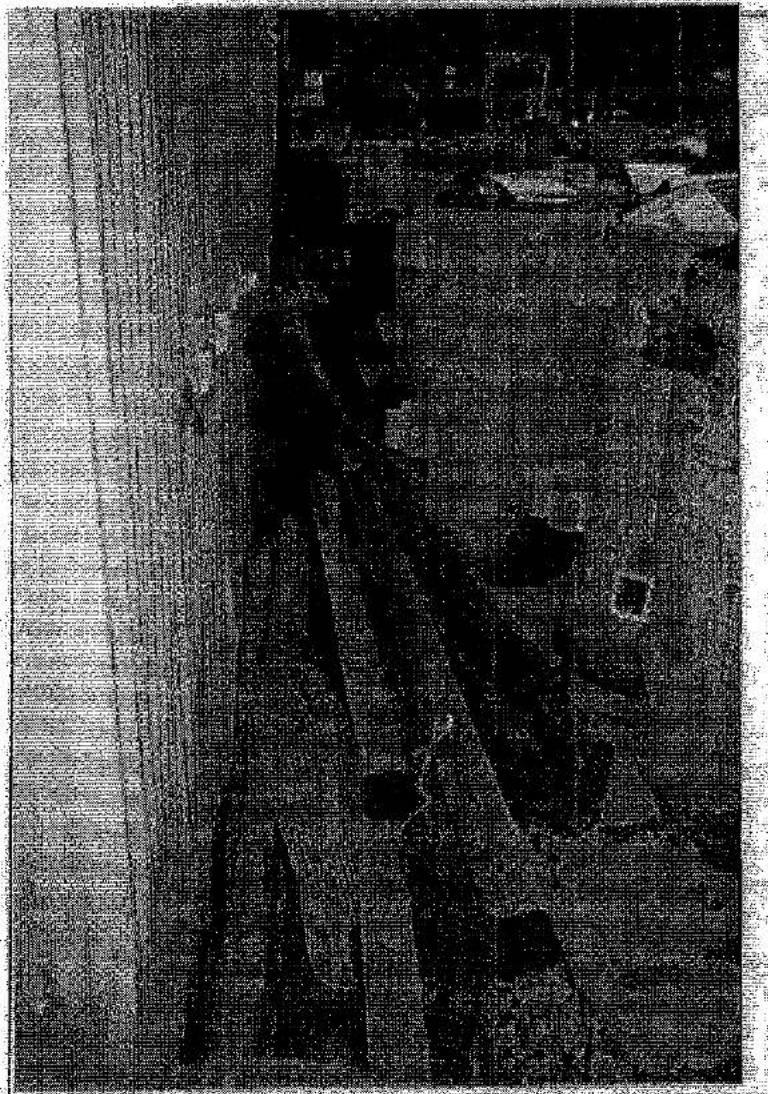
Photo No.
16

Description View along the north side of the shop. Note the staining and the condition of the transformers.
